Manhole Inspection Summary

Manhole # S71C1_003MH

Insp Date: **2/12/08 10:38 AM**

Location Address: **6526 Detroit Ave.**

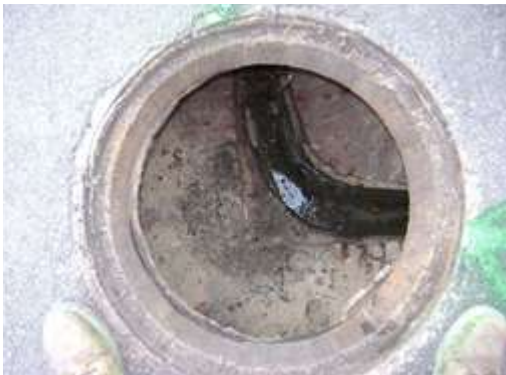
Defect 1

Condition: ☐ Sound ☐ Cracked ☐ Root Intrusion ☐ Deteriorated ☐ Leaks ☒ **Debris**

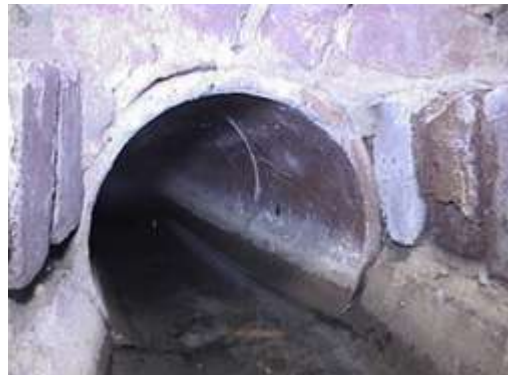
Defect 2

Comments **FIELD CREW VERIFIED INVERT DEPTH IS LOWER THAN OUTGOING INVERT DEPTH**

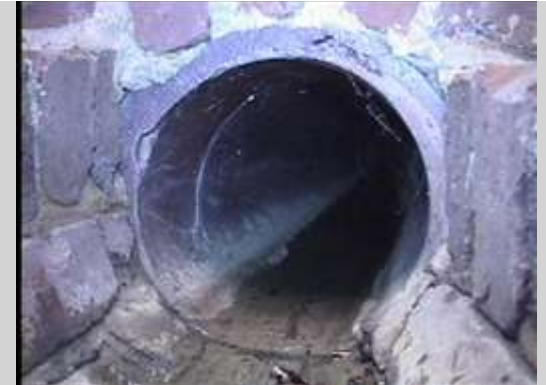
12 O'Clock Outflow

8 in. Circular Gravity Sewer
Pipe Out @ 12 O'Clock

Pipe Height: **8.4** (in.) Rod and Bar (Angled)
Pipe Material: **Clay** ☐ Pipe Lined
Invert Depth: **4.25** (ft.) Flow Characteristics: **Slow**
Deposits: ☐ None ☐ Mud ☒ **Gravy** ☐ Debris ☐ Grease
Silt Depth: **0.25** (in.) Deposits Extent: **Light**
Infiltration: **None** Pipe Seal Cond: **Sound**

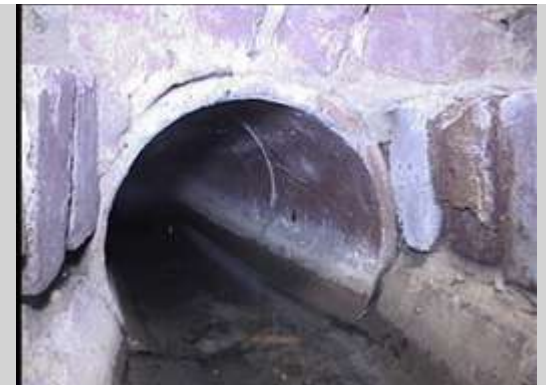
3 O'Clock Inflow

8 in. Circular Gravity Sewer
Pipe In @ 3 O'Clock

Pipe Height: **8.4** (in.) Rod and Bar (Angled)
Pipe Material: **Clay** ☐ Pipe Lined
Invert Depth: **4.29** (ft.) Flow Characteristics: **Slow**
Deposits: ☐ None ☐ Mud ☒ **Gravy** ☐ Debris ☐ Grease
Silt Depth: **0.25** (in.) Deposits Extent: **Light**
Infiltration: **None** Pipe Seal Cond: **Cracked**
